# FIELD INSPECTION REPORT

Project Name:	Mountain Valley Pipeline	Inspector:	Matthew Grant
Inspection Date:	Monday, October 25, 2021	Project Contact:	Brian Clauto
Spread H: Roanoke	AR 288, 287 St12940-12955	Weather:	Dry

# FIELD INSPECTION PHOTO LOG

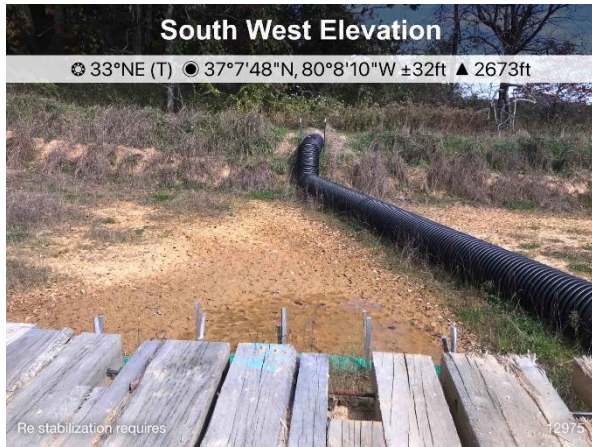
- Sta. 12970+00 – 12972+00 ROW and stockpiles lack adequate stabilization / erosion control matting deteriorated
- Sta. 12966+00 - 12960+00 ROW lacks adequate stabilization / erosion control matting deteriorated. Re-stabilize where needed
- Sta. 12975+00 ROW lacks adequate stabilization
- Sta. 12955+00 – 12953+00 Stockpiles lack adequate stabilization / erosion control matting deteriorated

- Figure 1: Additional stabilization required near Sta 12975

**Recommended Corrective Action:** Maintain and install all controls per the approved PSS&S.

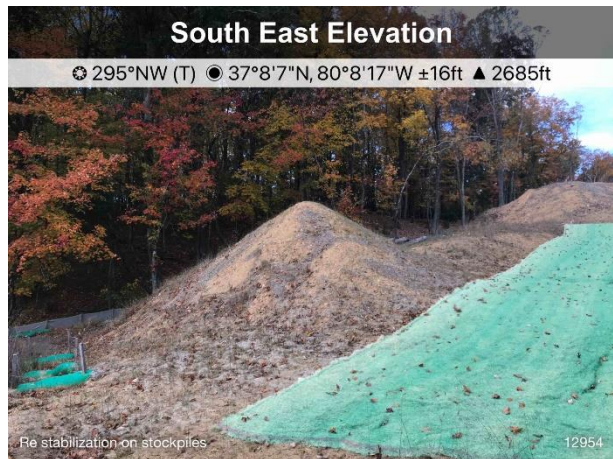
- Figure 2: Stockpile near Sta 12954 requires additional stabilization.

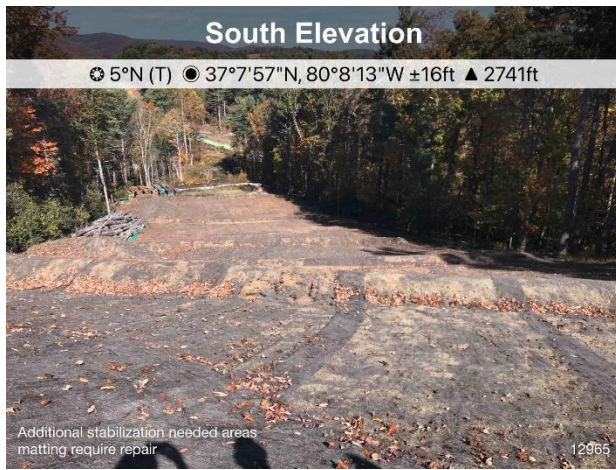
- Figure 3: Sta 12965 additional stabilization and matting repair is required in some areas to Sta 12960

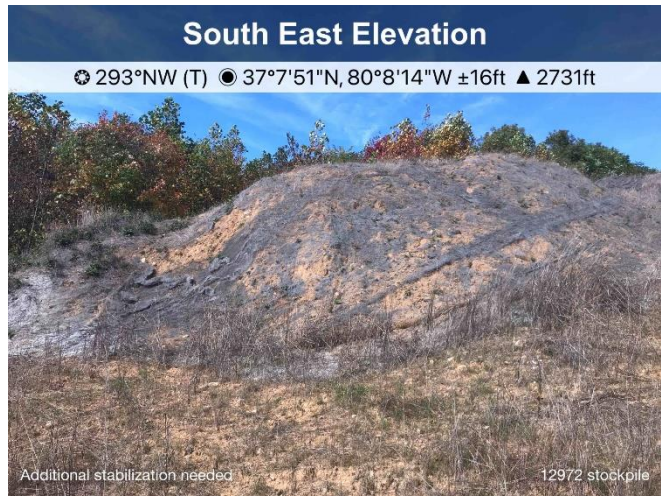
- Figure 4: Sta 12972 Stockpile requires additional stabilization
